# Manhole Inspection Summary

Manhole # S27G\_\_013MH

Insp Date: **5/23/08 9:01 AM**

**Location** Address: **1000 schroeder st**

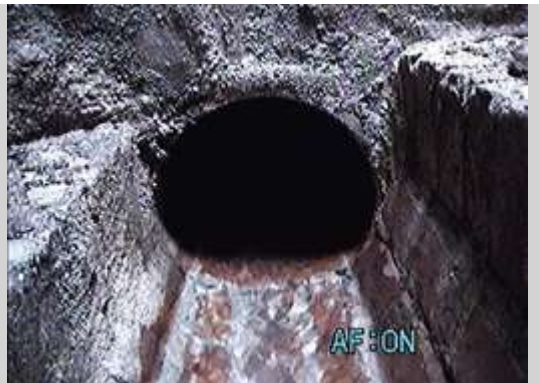
6 O'Clock Inflow

8 in. Circular Gravity Sewer  
Pipe In @ 6 O'Clock

Pipe Height: **8.4** (in.) Rod and Bar (Angled)  
Pipe Material: **Clay** ☐ Pipe Lined  
Invert Depth: **10.17** (ft.) Flow Characteristics: **Fast**  
Deposits: ☒ None ☐ Mud ☐ Gravy ☐ Debris ☐ Grease  
Silt Depth: **0** (in.) Deposits Extent:  
Infiltration: **None** Pipe Seal Cond: **Sound**
